Service Manual

Energy Recovery Ventilator

FV-16VEC1T

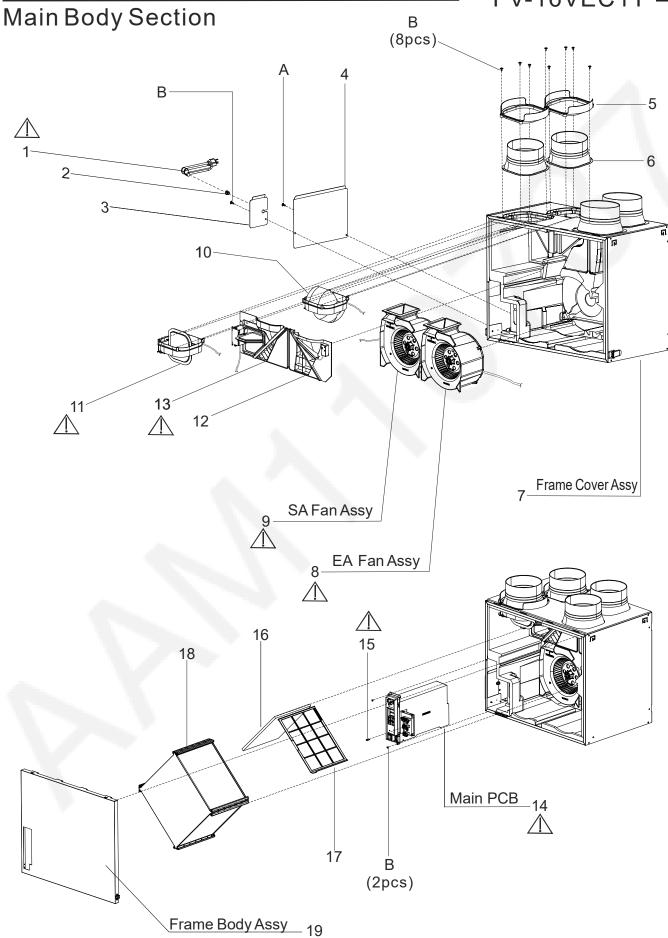
FV-16VEC1T —

Main Body Section

No.	Part No.	Part Name	Q′ty	Remark
1	FFV16VC1T204	Power Cord	1	\triangle
2	FFV0720012S	Cord Bushing	1	
3	FFV16VC1T954	Wiring Cover P	1	
4	FFV16VC1T951	Main PCB Cover	1	\sim \sim
5	FFV16VC1T911	Adapter Cover	2	
6	FFV16VC1T917	Adapter	2	
7	FFV16VC1T901	Main Frame	1	
8	FFV16VC1T120	EA Fan Assy	1	\triangle
9	FFV16VC1T110	SA Fan Assy	1	\triangle
10	FFV16VC1T520	Damper EA Assy	1	
11	FFV16VC1T530	Damper OA Assy	1	\triangle
12	FFV16VC1T560	Separator R Assy	1	
13	FFV16VC1T550	Separator L Assy	1	\triangle
14	FFV16VC1T510	PCB Case Assy	1	\triangle
15	FFV2800028S	Jumper Cable	1	\triangle
16	FFV16VC1T811	RA Filer	1	
17	FFV16VC1T801	OA Filter M13	1	
18	FFV16VC1T990	Element Comp Unit	1	
19	FFV16VC1T934	Frame Cover Assy	1	
Α	FFVXTT4-8FFJ	Truss Taptite S	1	
В	FFVXTT412GFJ	Truss Taptite P	12

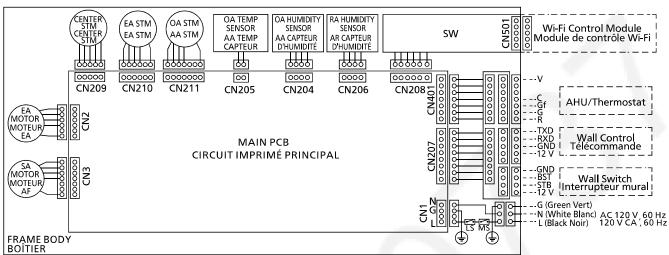
3. Wiring diagram

STM: Stepper Motor Moteur à engrenages
LS: Limit Switch Interrupteur de fin de course
SW: Switch PCB Circuit imprimé du commutateur

MS: Main Switch Interrupteur principal

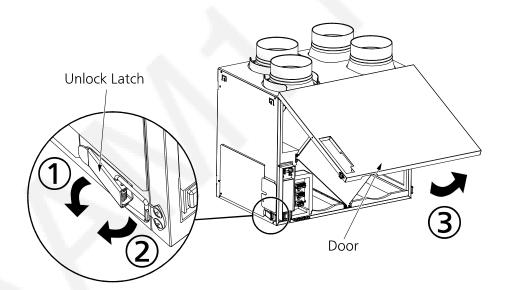
- Electric shock may result. Disconnect power by switching off main switch, then unplug before working on the unit. If a standby switch is connected, it is recommended to switch it off first.
- Routine maintenance must be performed every 2 or 3 months. clogged filters may cause condensation on the unit due to air flow reduction.
- Please wear gloves to avoid pinching fingers during maintenance.
- Please pay attention to dust, condensation water, or parts that may drop down when the door is opened.
- \bigcirc Never use gasoline, benzene, thinner or any other such chemicals to clean the ERV.
- igcolon D Do not allow water to enter ERV.
- \bigcirc Do not immerse resin parts in water over 60 °C.
- 1 Open the door by unlocking the latches.

Clean the OA filter, RA filter and energy 2 recovery core.
